# Cleaning Drum Lenses Can Quickly Improve Quality.

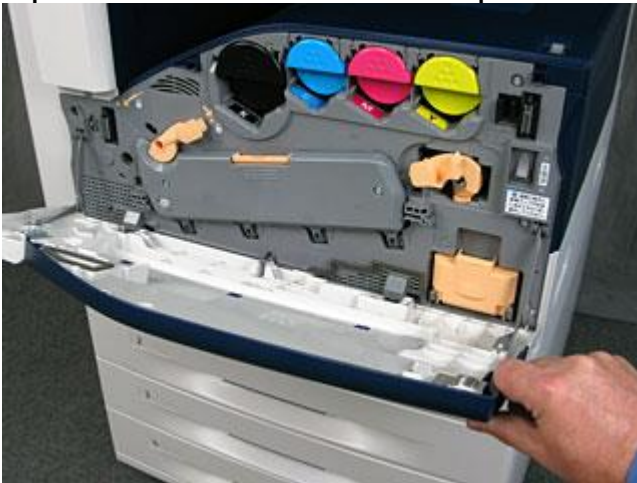
1. Open the Front Cover of the printer.

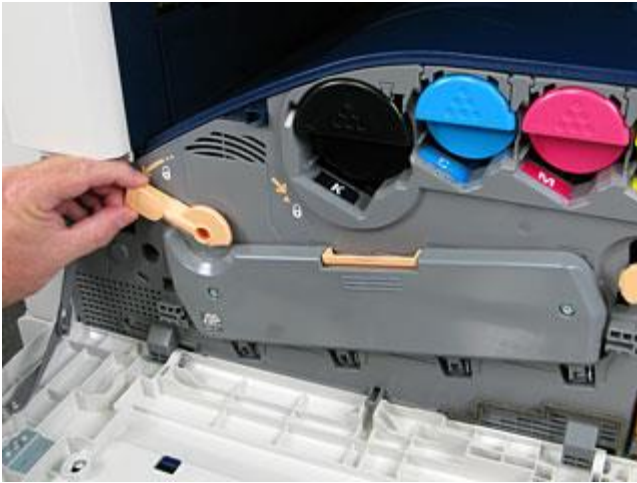
2. Turn the orange lever to the left

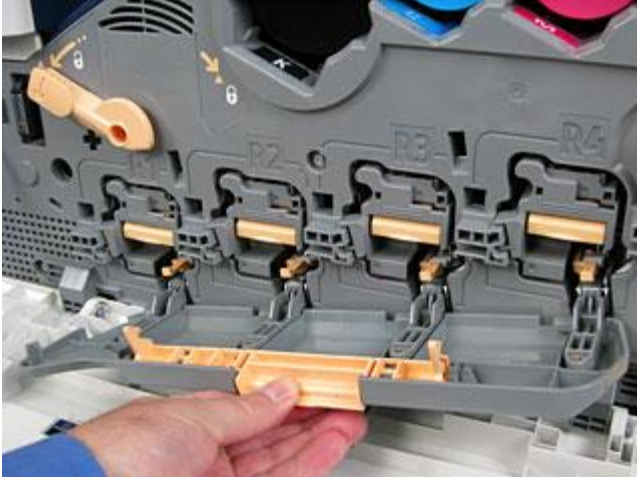
3. Pull the Drum Cartridge Cover down until it clicks into the open position.

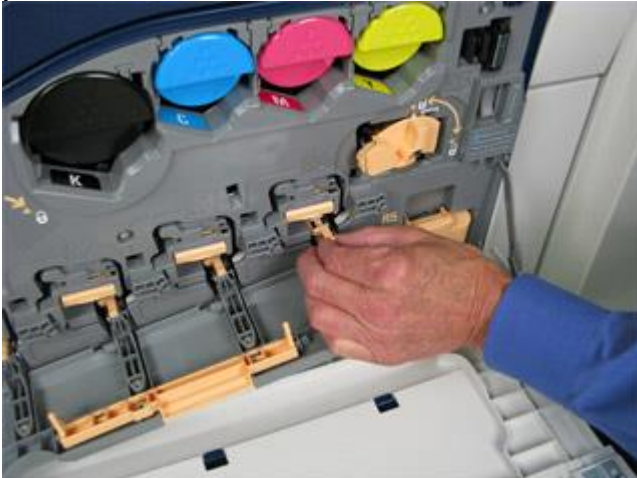
4. Each of the four printheads has its own cleaning tool. Slowly pull the printhead lens cleaner out until the three dots are visible.

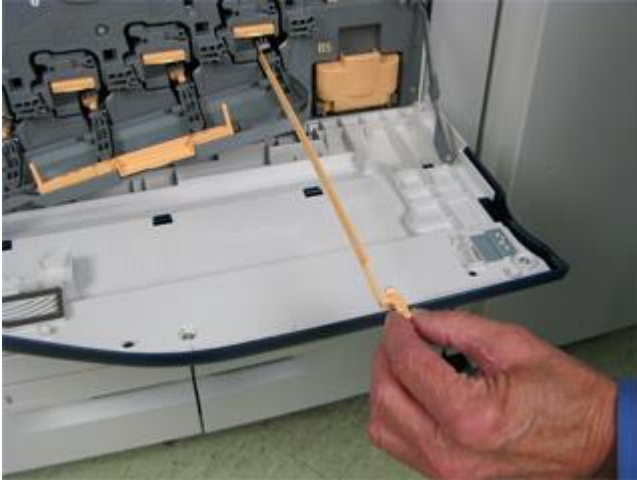
**NOTE:** The printhead lens cleaner does not detach from the printer.

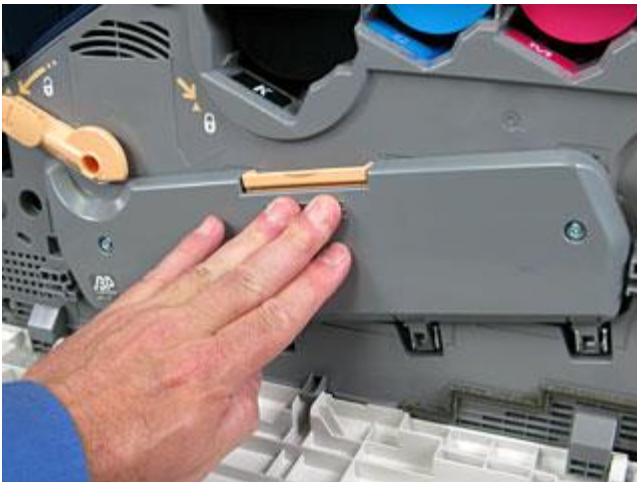
5. Slowly push the printhead lens cleaner back into the printhead until it stops.
6. Repeat steps 4 and 5 for each printhead.
7. Close the Drum Cartridge Cover
